2014 FAA Worldwide Airport Technology Transfer Conference

REHABILITATION OF WATER-DAMAGED RUNWAY COMPOSITE PAVEMENTS

Narita International Airport Corporation

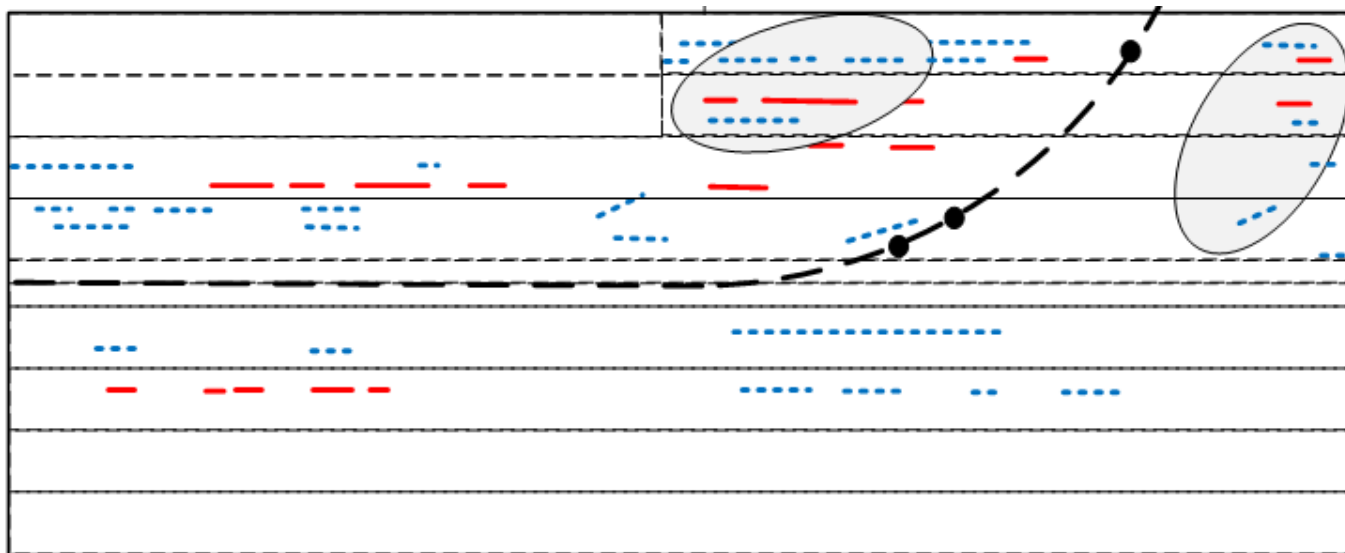
- Composite pavements
 - Open to aircraft operation in April 2012
- Some signs of distress
 - Appeared on surface a few months later

- Concaved surface
- Stains at construction joints
- Black & White spots
- Flow of AM around lighting

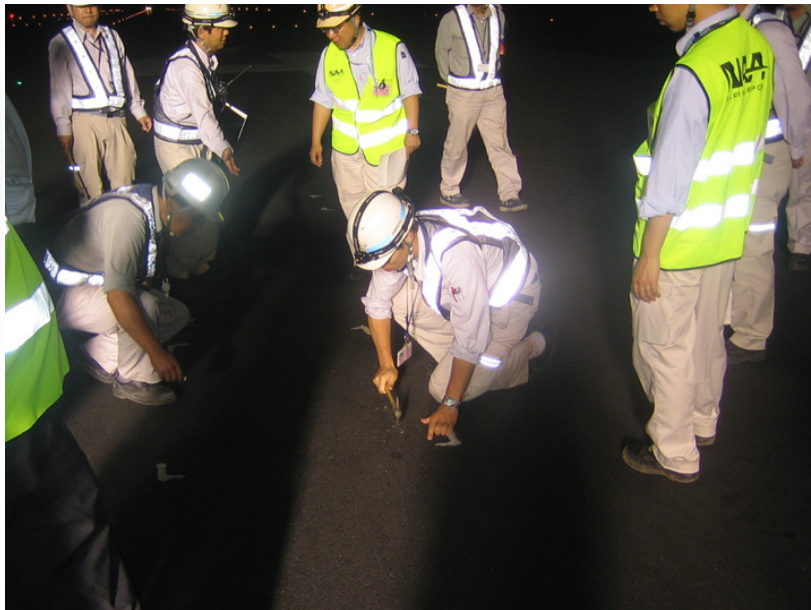
- Dull sound at hammer tapping tests

- ❧ Dull sound at hammer tapping tests
 - ❧ Insufficient stability of AM
 - ❧ DS was lower than the new standard
 - ❧ Air void was below the standard
 - ❧ Water remained in AM
 - ❧ Might cause blistering
- ❧ Black & white spots and stains at joints
 - ❧ Asphalt exfoliation & efflorescence from concrete were found
- ❧ Flow of AM around airport lighting
 - ❧ Insufficient stability of AM

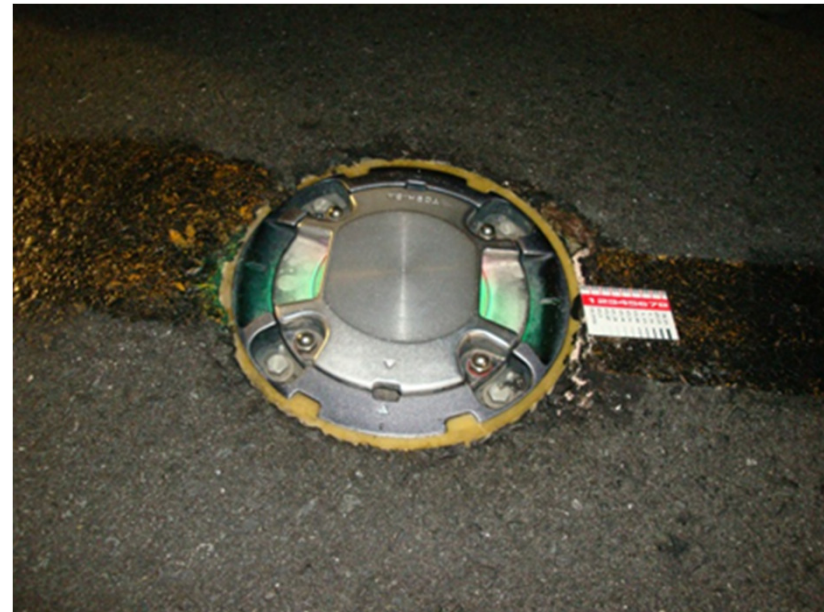
- Flow of AM around airport lighting

- Asphalt mixture with DS > 3,000 times/mm is required.
 - PMA Type II is adopted for surface course
 - PMA Type H is adopted for binder course

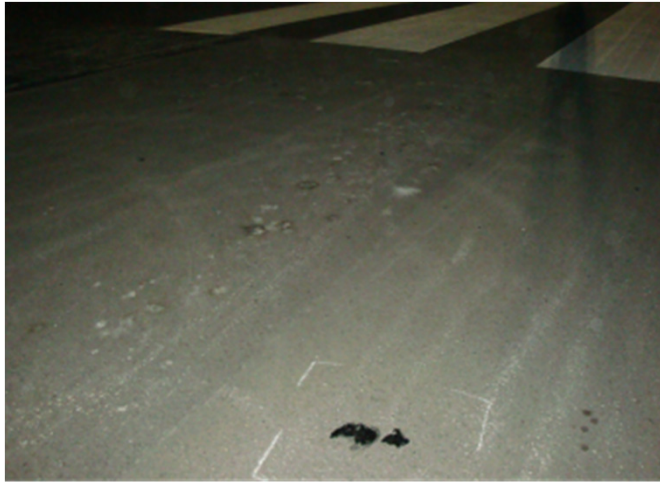
❧ Black spots

- ❧ Black spots
 - ❧ Composed of the same substances as asphalt emulsion and asphalt
- ❧ White spots
 - ❧ Recognized as inorganic and containing calcium carbonates
 - ❧ No obvious differences at fractured planes and others
- ❧ Stains at construction joint
 - ❧ Made of the same substances as white spots

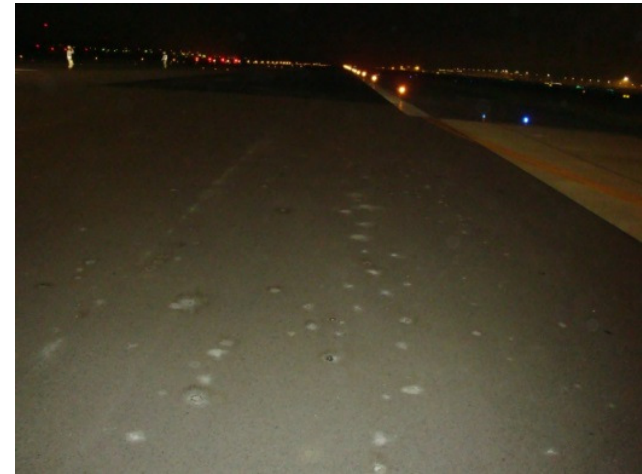
❧ White spots

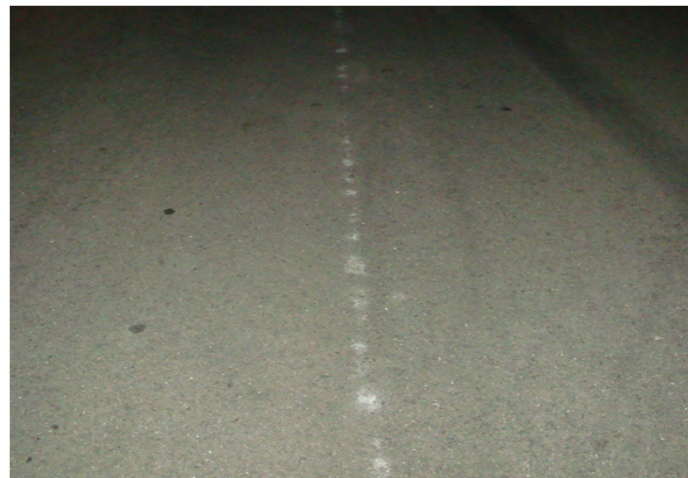
❧ Stains at construction joints

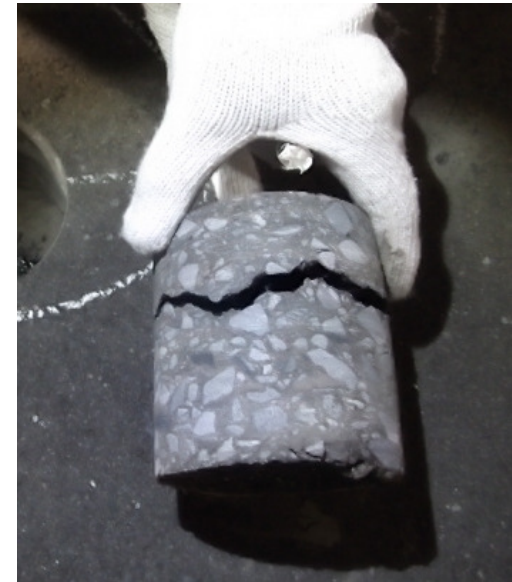
❧ Fracture of AM

- ❧ Marks of slippage between AM and CRC
- ❧ Fractured planes in AM and at AM interface

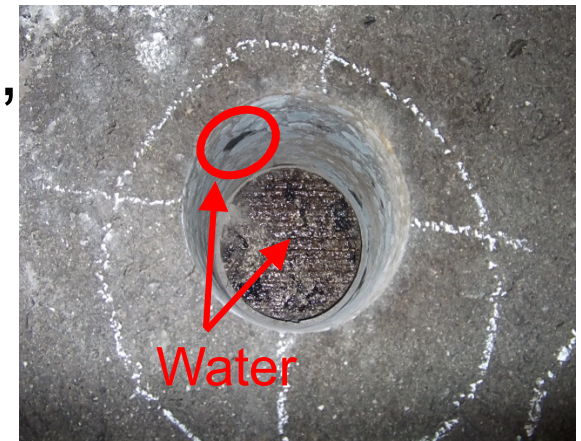
❧ Water in AM

- ❧ Found between AM and CRC, and in the fractured planes.

- ❧ Intrusion of water into AM
 - ❧ AM layers with low air voids were surrounded by CRC on the bottom and all sides.
 - ❧ Once water has permeated the pavement, it cannot naturally escape from it.
- ❧ Low stability of AM
 - ❧ Stability of AM insufficient to carry heavy aircraft loads resulted in plastic deformation progressed by repeated load applications.
